# Manhole Inspection Summary

Manhole # S37QQ\_003MH

Insp Date: **1/17/07 8:20 AM**

**Location** Address: **2511 26TH ST**

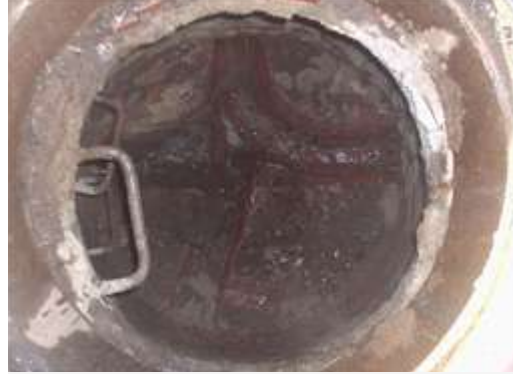
Top View

Corroded steps. Evidence of surcharge - Bench debris. Channel debris.

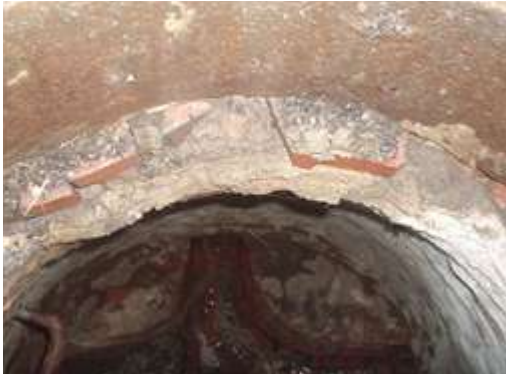
Defect

Frame leaks. Frame offset. Adjustment deterioration, loose brick and infiltration. Barrel infiltration.

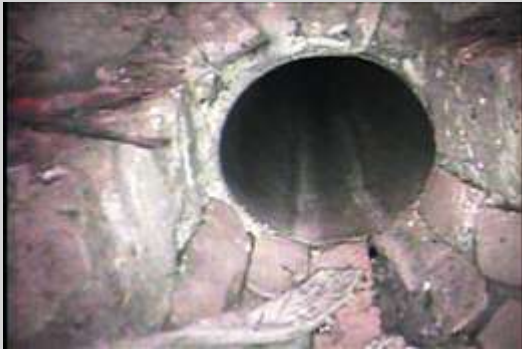
### 8 in. Circular Gravity Sewer Pipe Out @ 12 O'Clock

Channel deterioration.

Infiltration: **Evidence** Pipe Seal Cond: **Unknown**

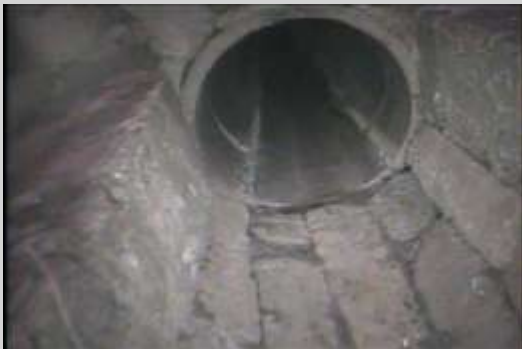
### 8 in. Circular Gravity Sewer Pipe In @ 3 O'Clock

Infiltration: **Evidence** Pipe Seal Cond: **Unknown**

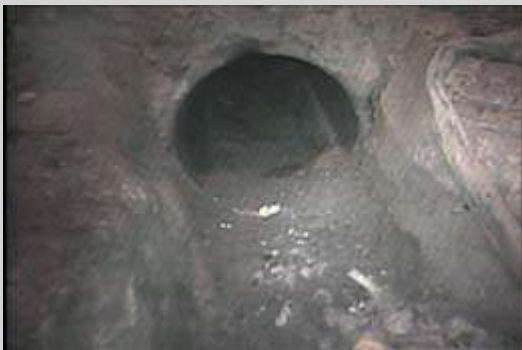
#### Pipe In @ 9 O'Clock

Rod and Bar (Angled)  
Pipe Material: **Clay** ☐ Pipe Lined  
Invert Depth: **6.60** (ft.) Flow Characteristics: **None**  
Deposits: ☐ None ☒ **Mud** ☐ Sludge ☒ **Debris** ☐ Grease  
Silt Depth: **1** (in.) Deposits Extent: **Light**  
Infiltration: **Evidence** Pipe Seal Cond: **Unknown**
